BAOBAB FARMS DAMAGE ASSESSMENT FORM

Building Name "HICKMAN HSE"
Address 15401 SW 260 ST (HICKMAN DRIVE) Eric Miller (resident)
City (or Vicinity) and County Miami FL 33032 (Redlands) 245-2021
Owner STEVE KATZ

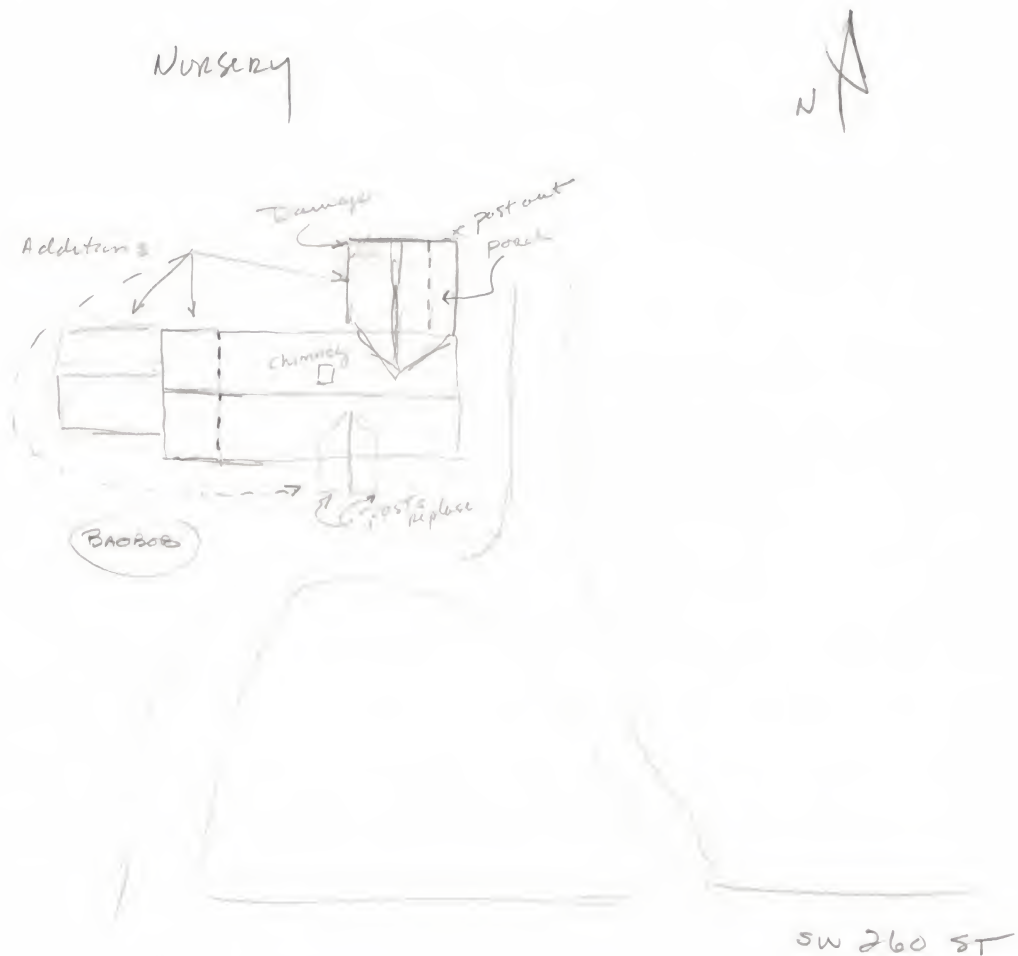
Site Sketch:

BAOBAB - damaged - standing w/ heavy cut back
KAROK - destroyed
PALMS - destroyed
